MEMORANDUM

RE: Site History: South Dayton Dump and Landfill, Moraine, Ohio (Site)

Site Background and Overview of Site History

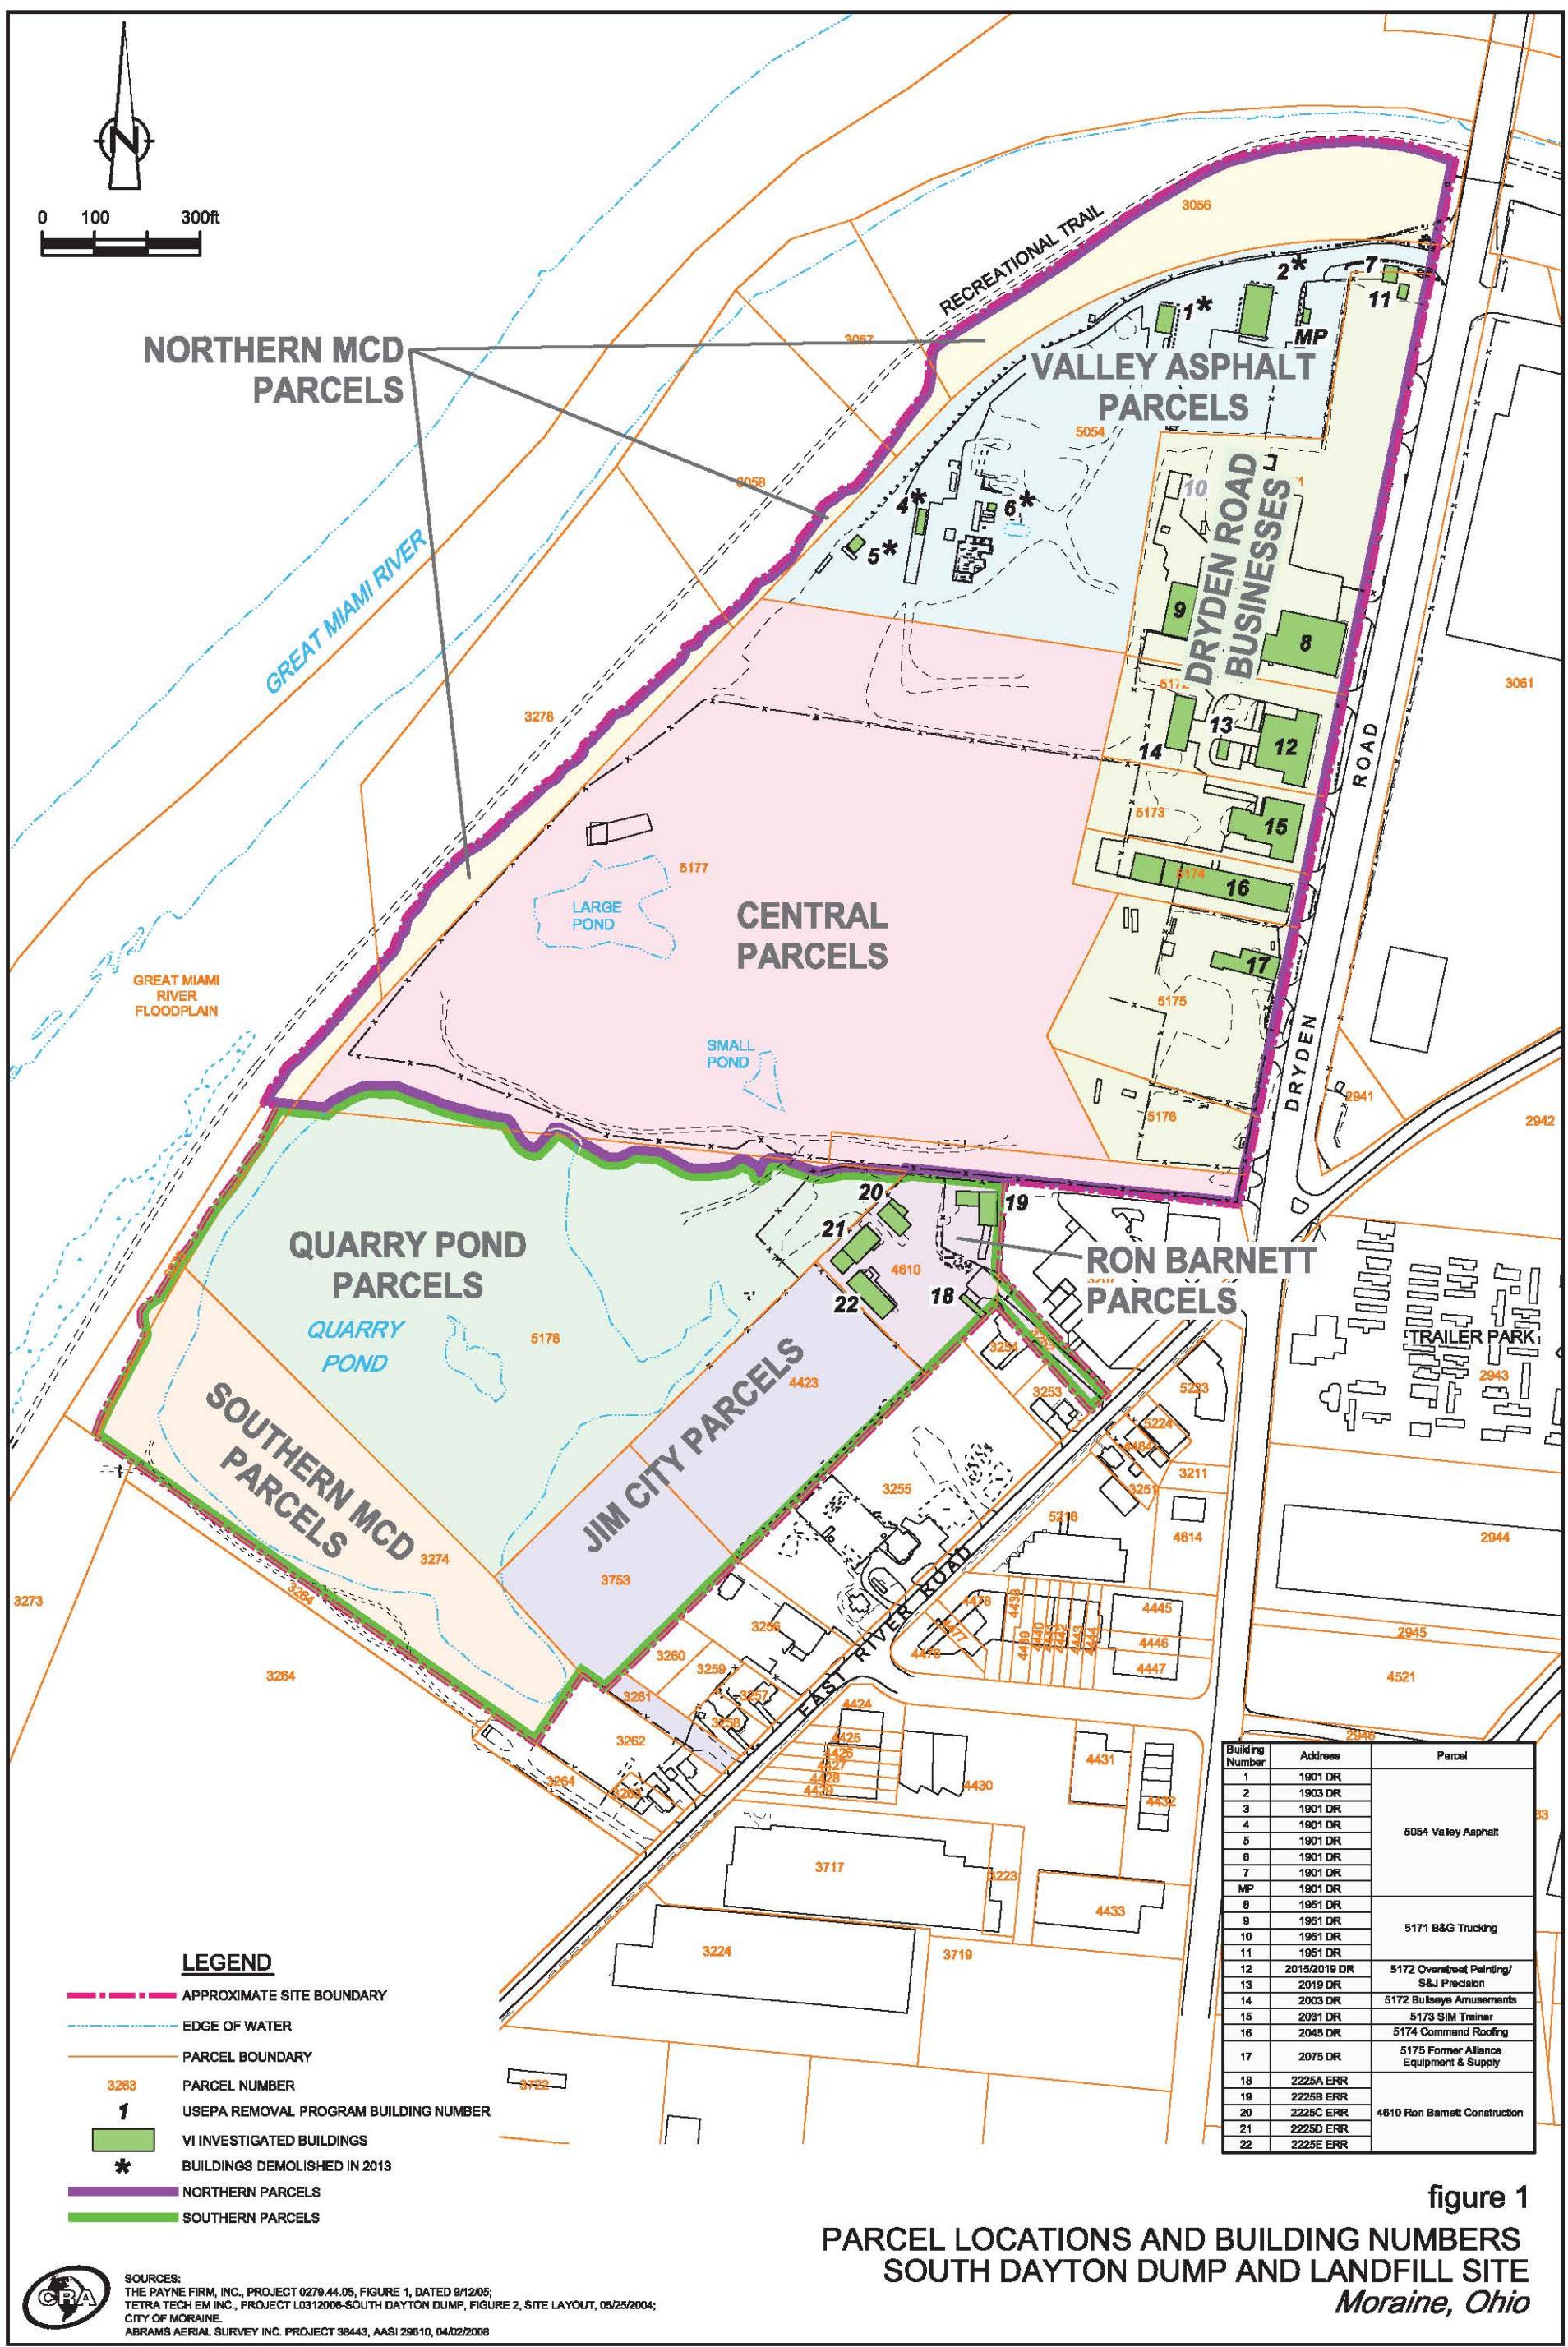
figure 1
PARCEL LOCATIONS AND BUILDING NUMBERS
SOUTH DAYTON DUMP AND LANDFILL SITE
Moraine, Ohio

CRA has divided the Parcels into groups for discussion based on the sequence of filling, the types of waste and fillⁱⁱⁱ visually observed at investigated locations, and the general location with respect to type within the Site boundary, as shown on Figure 1 and described as follows:

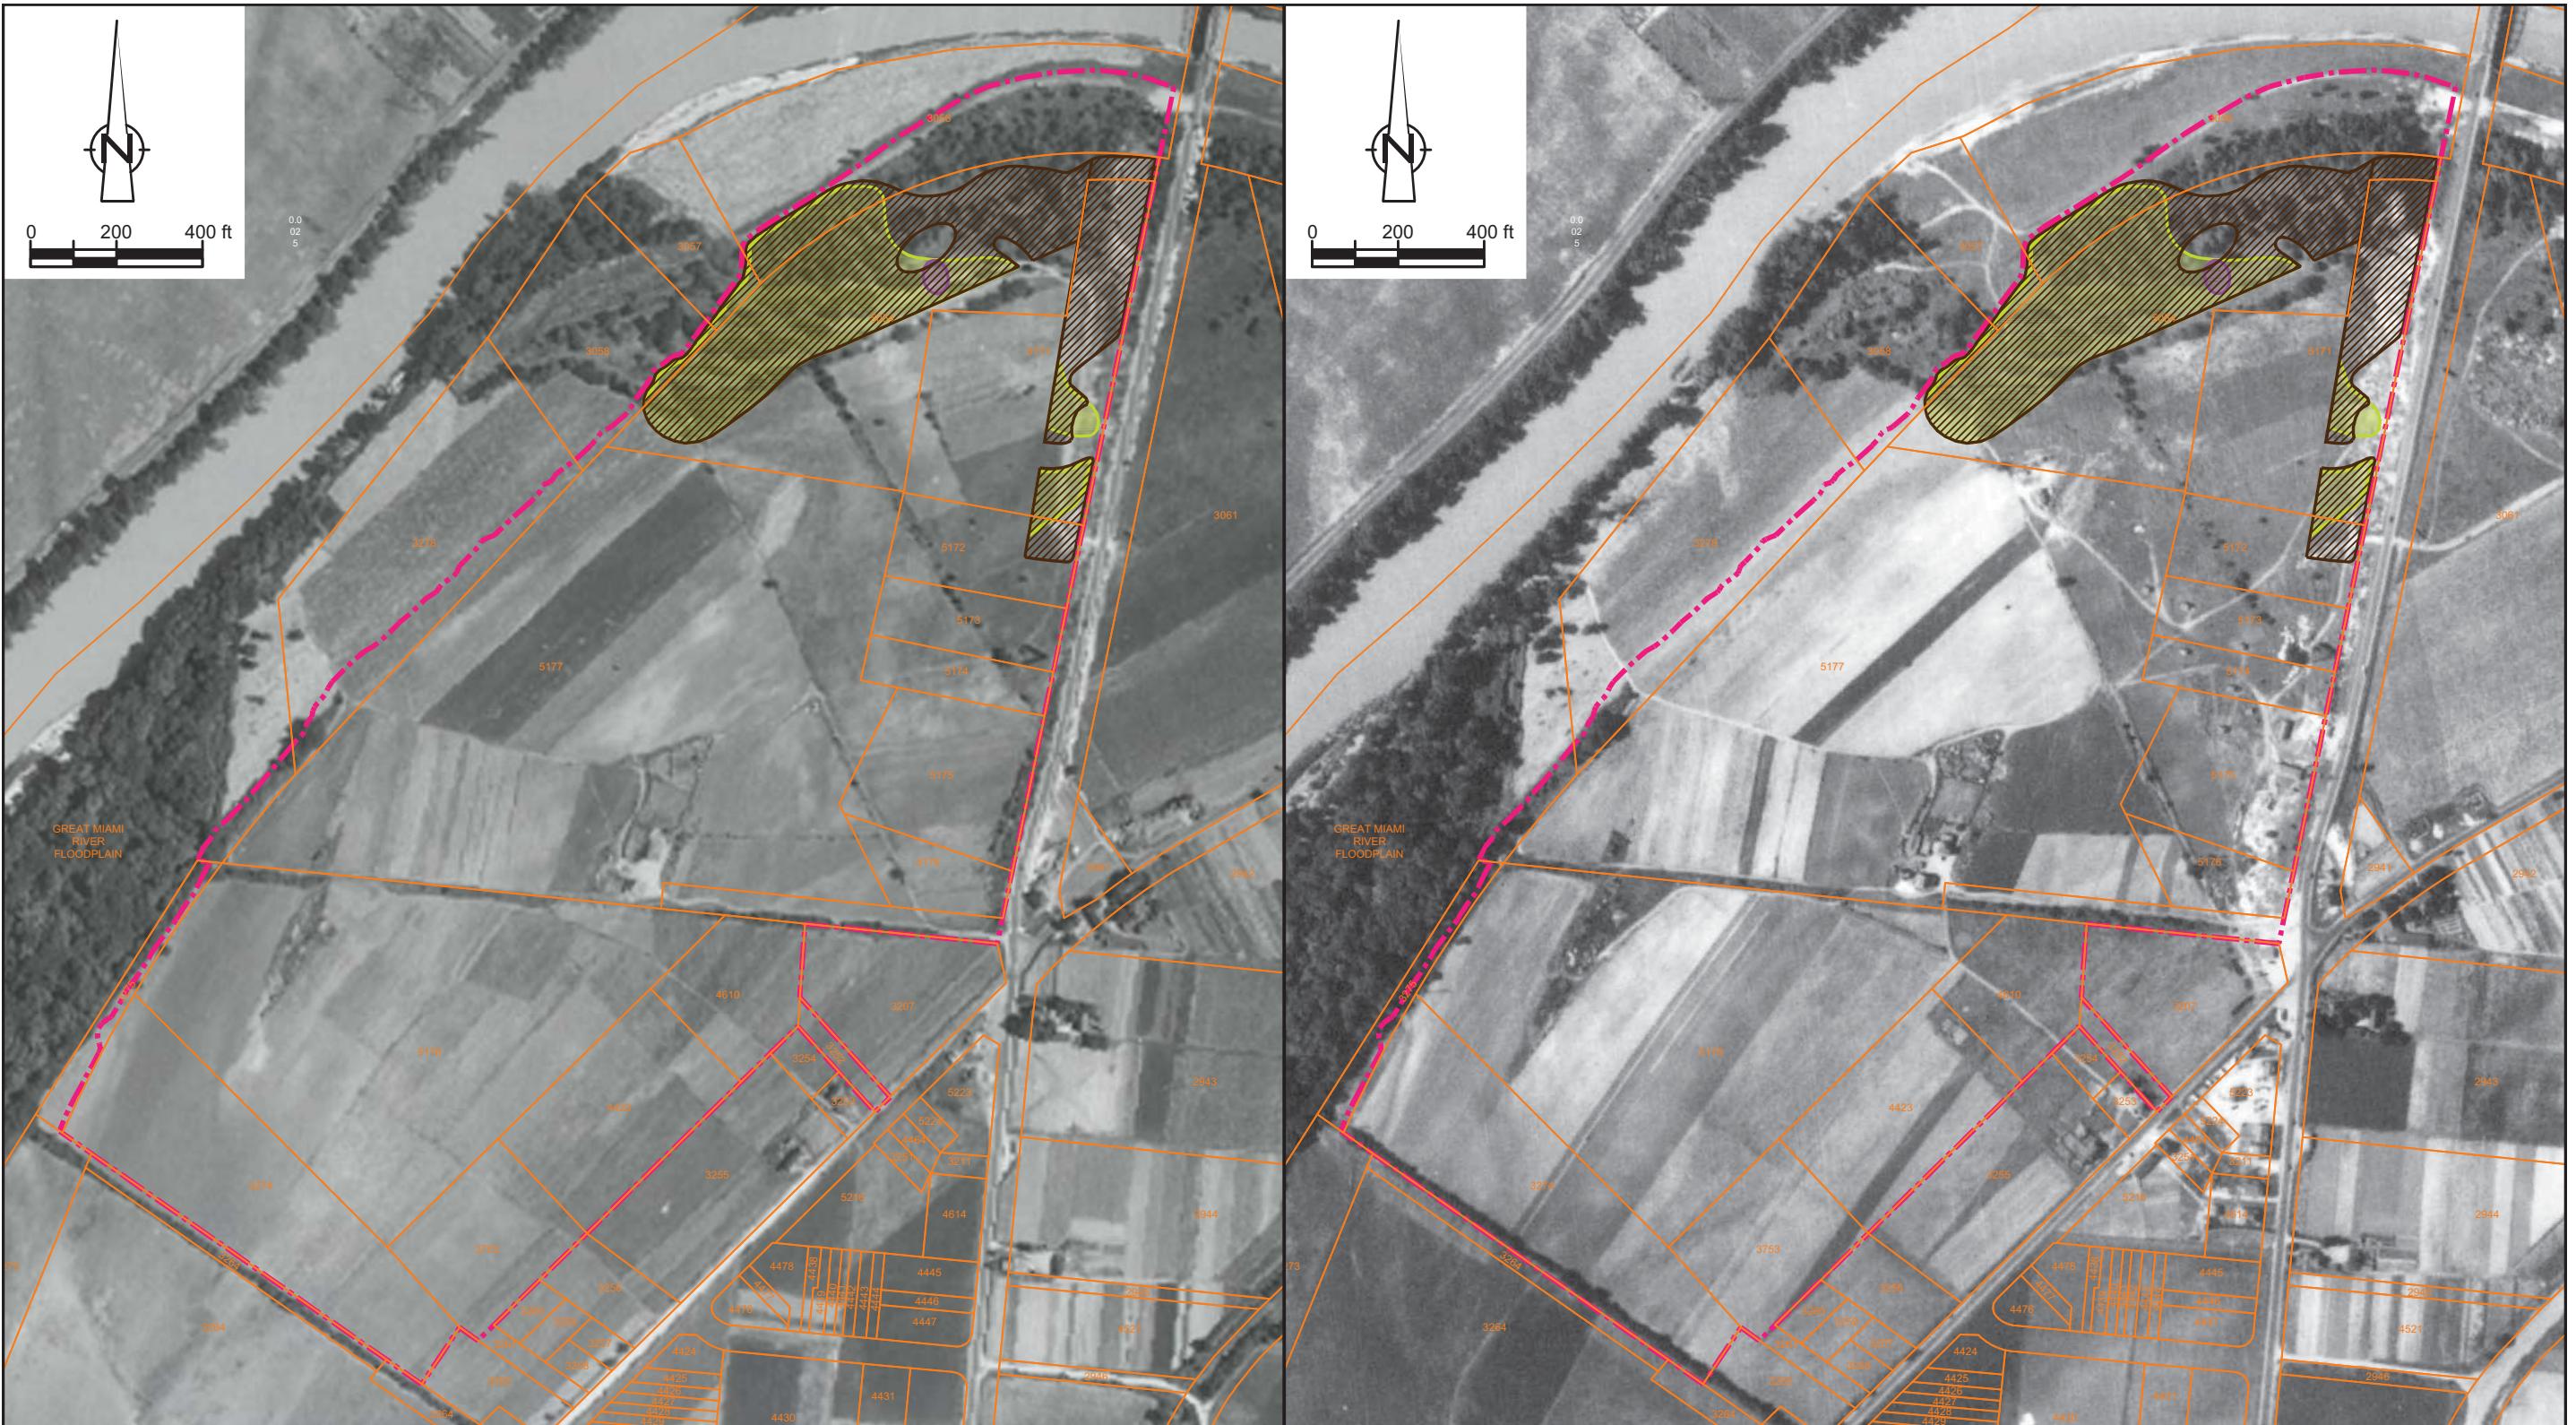
figure 2

AERIAL PHOTOS PRE-1945
SOUTH DAYTON DUMP AND LANDFILL SITE
Moraine, Ohio

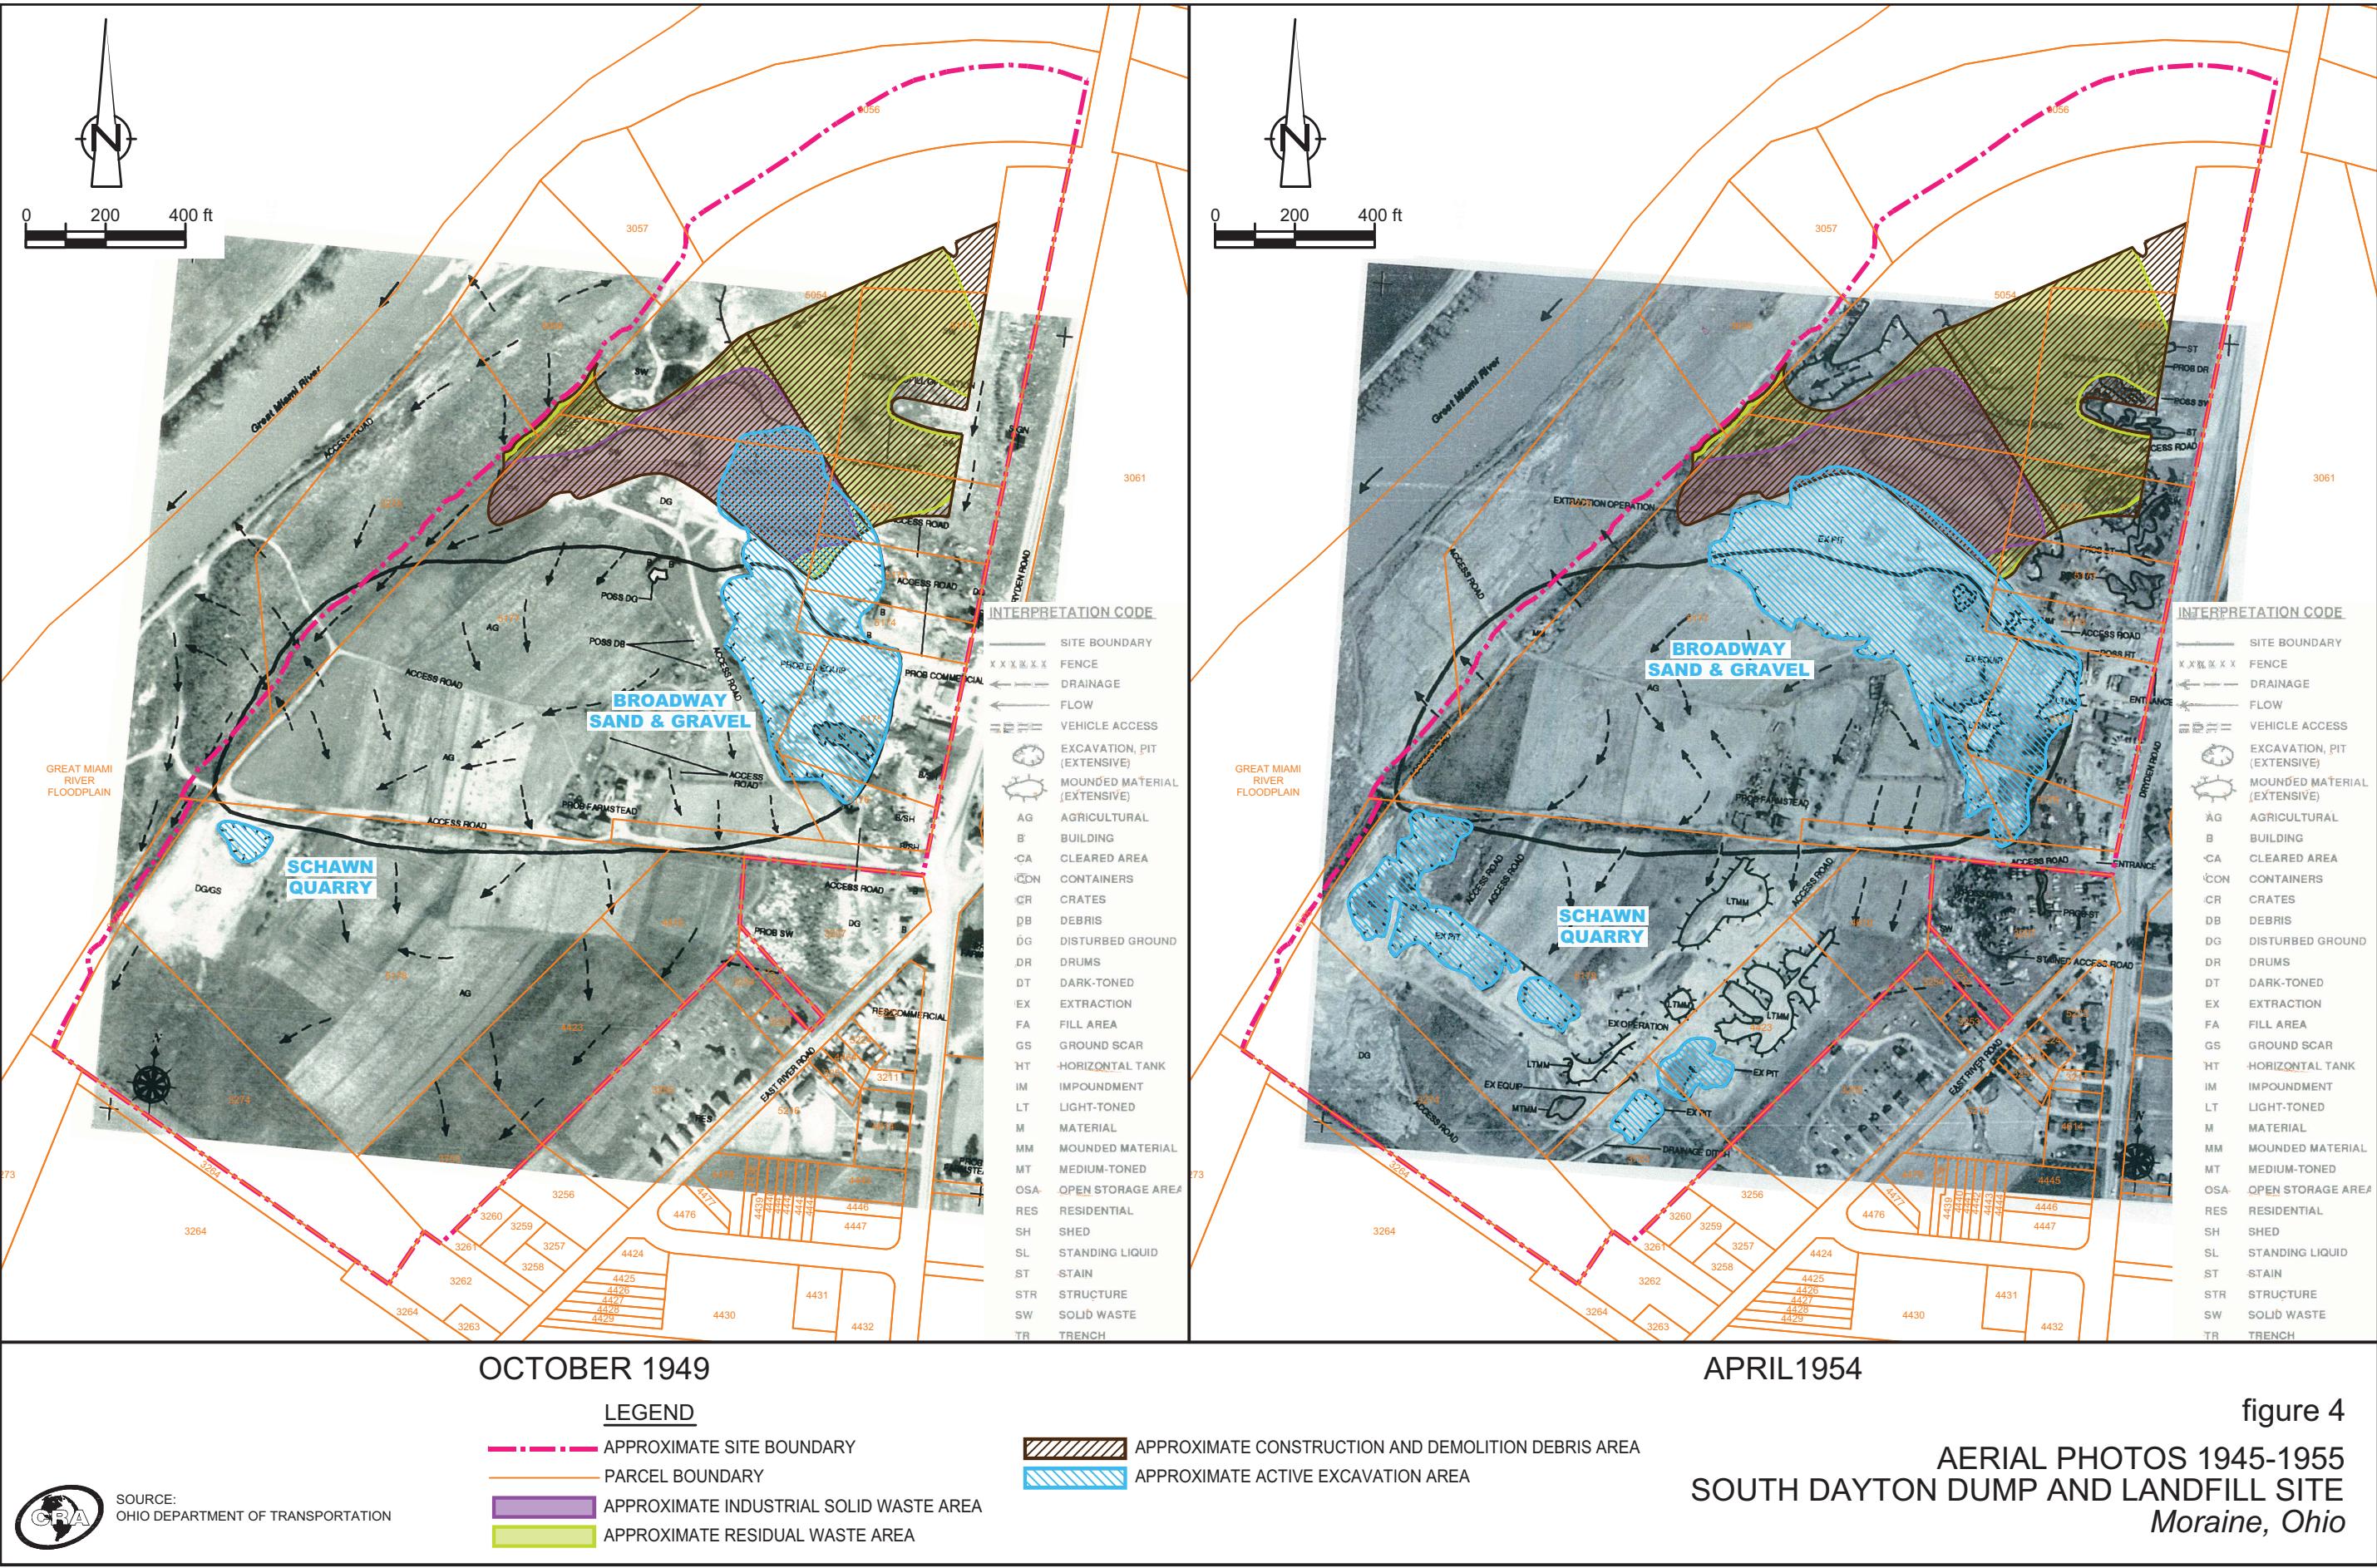
figure 4

AERIAL PHOTOS 1945-1955
SOUTH DAYTON DUMP AND LANDFILL SITE
Moraine, Ohio

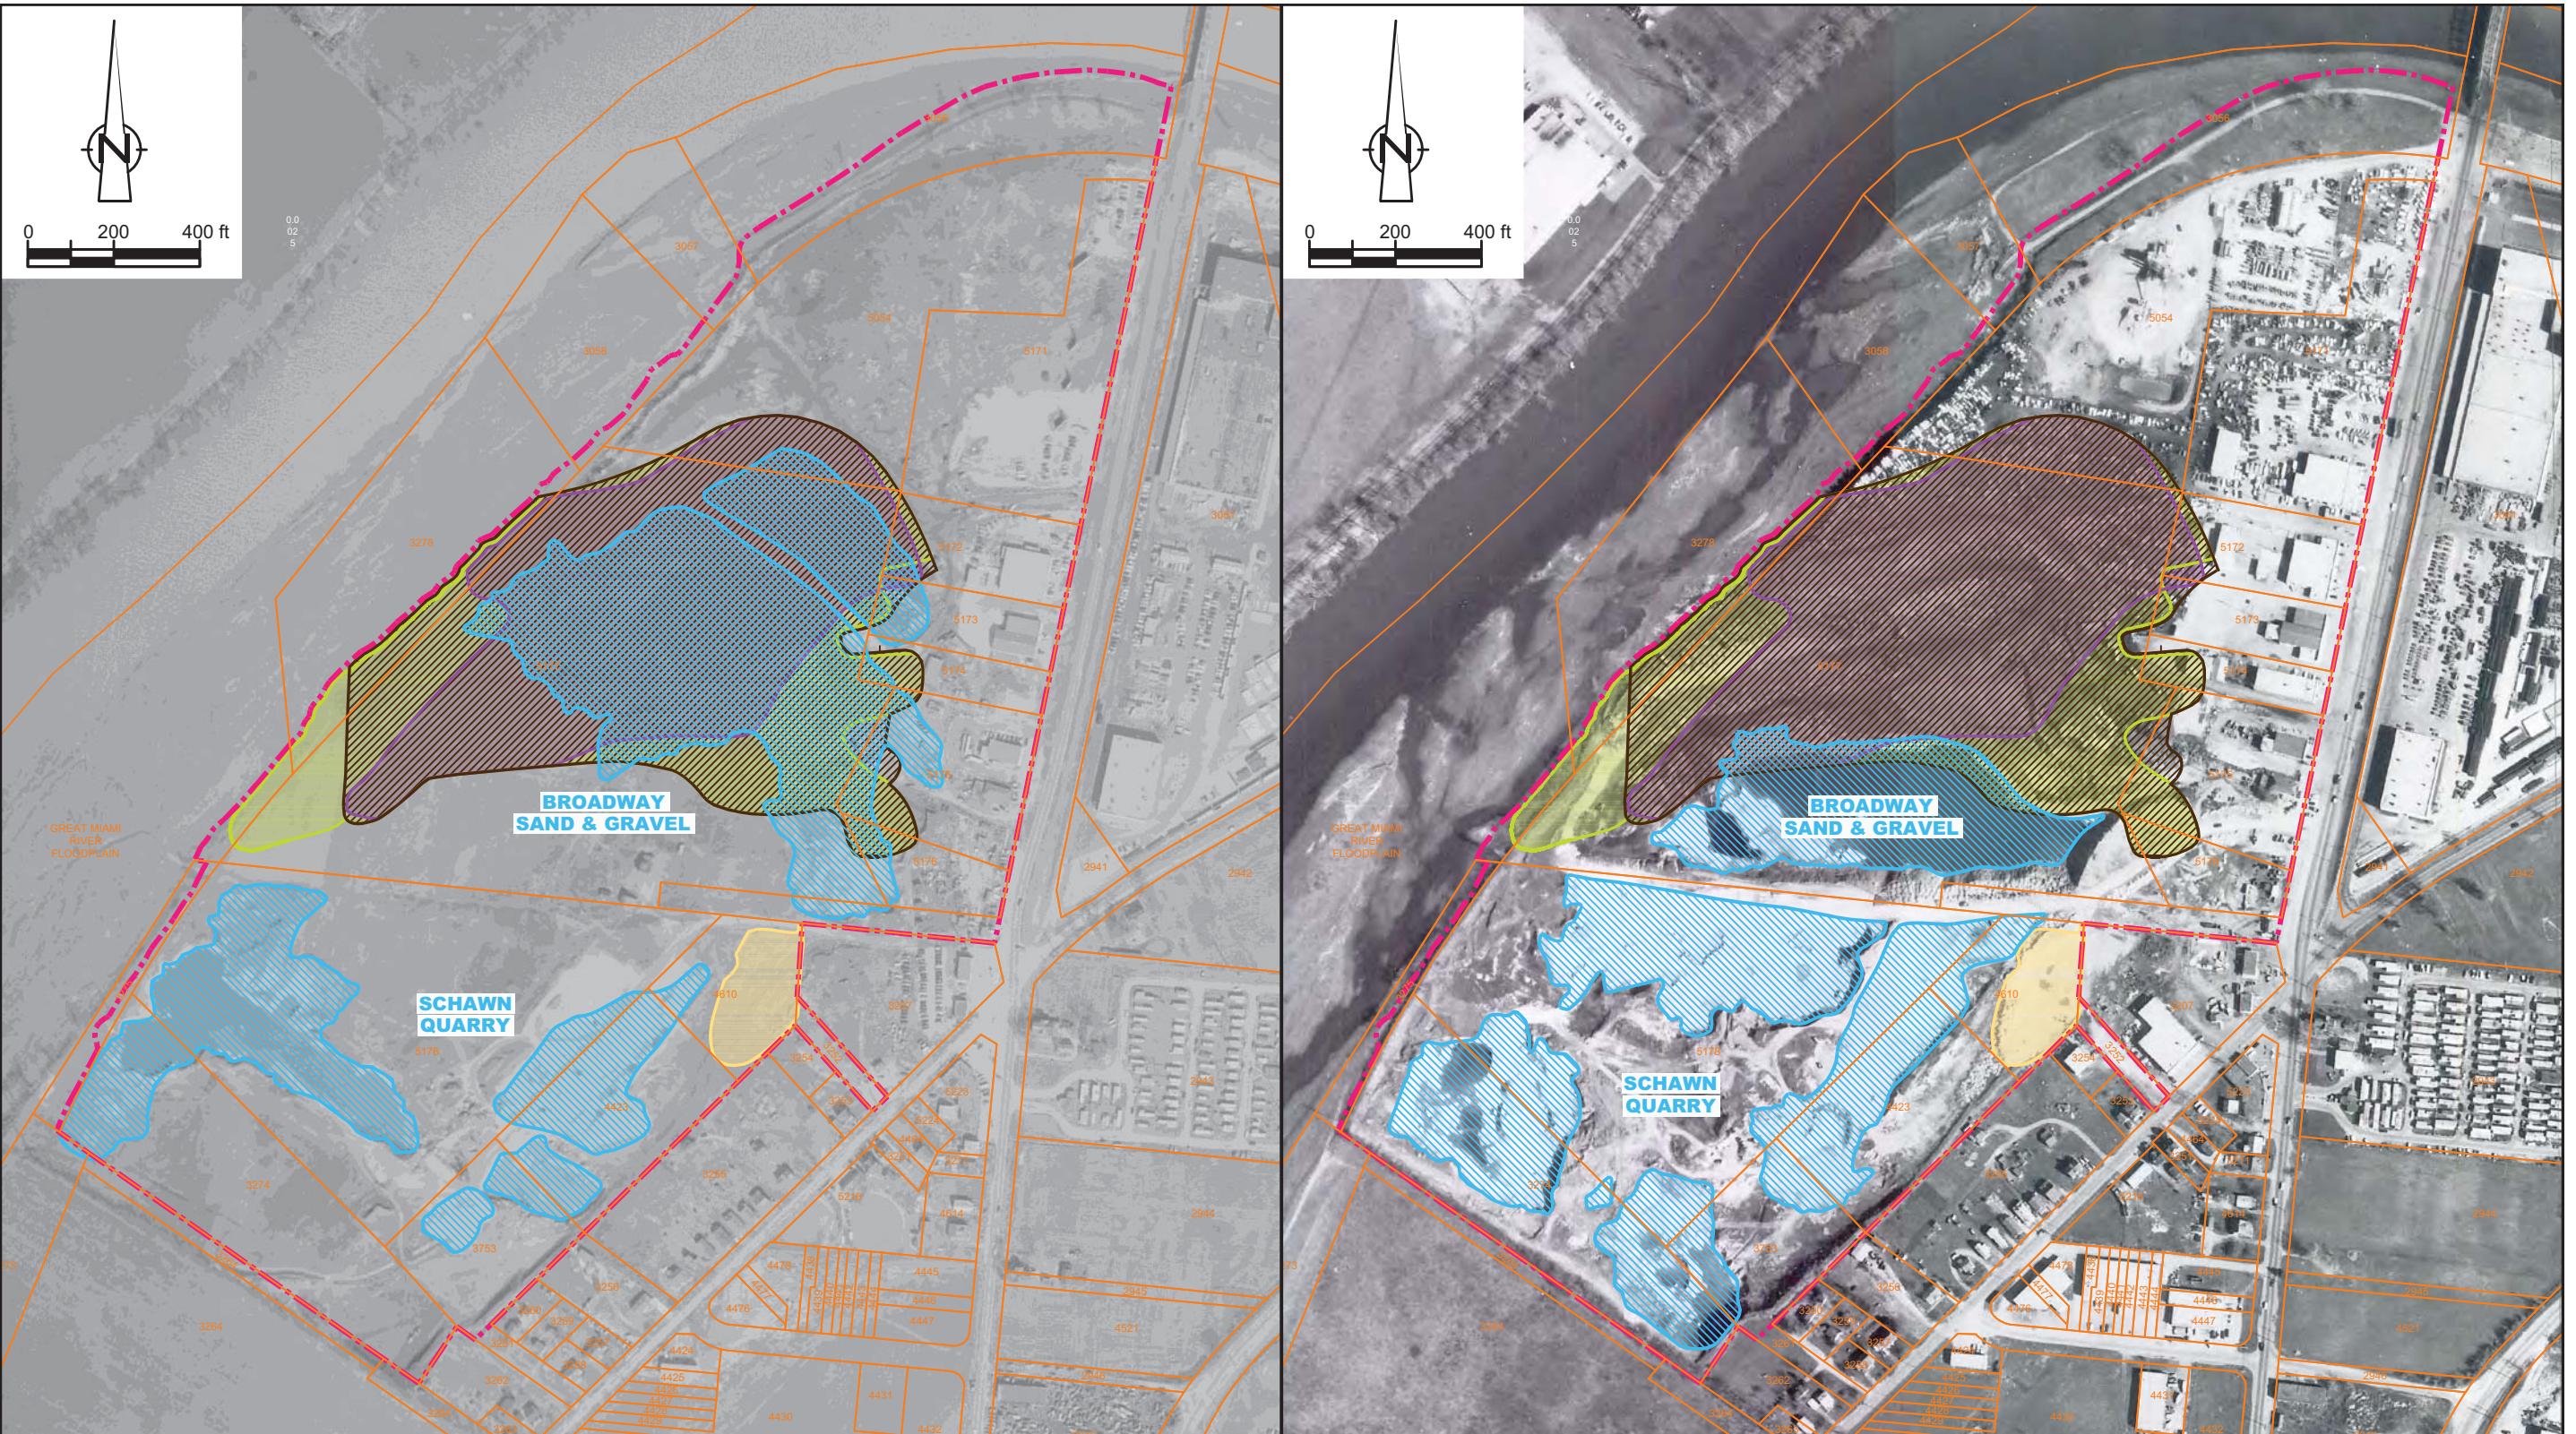
figure 6

AERIAL PHOTOS 1956-1968
SOUTH DAYTON DUMP AND LANDFILL SITE
Moraine, Ohio

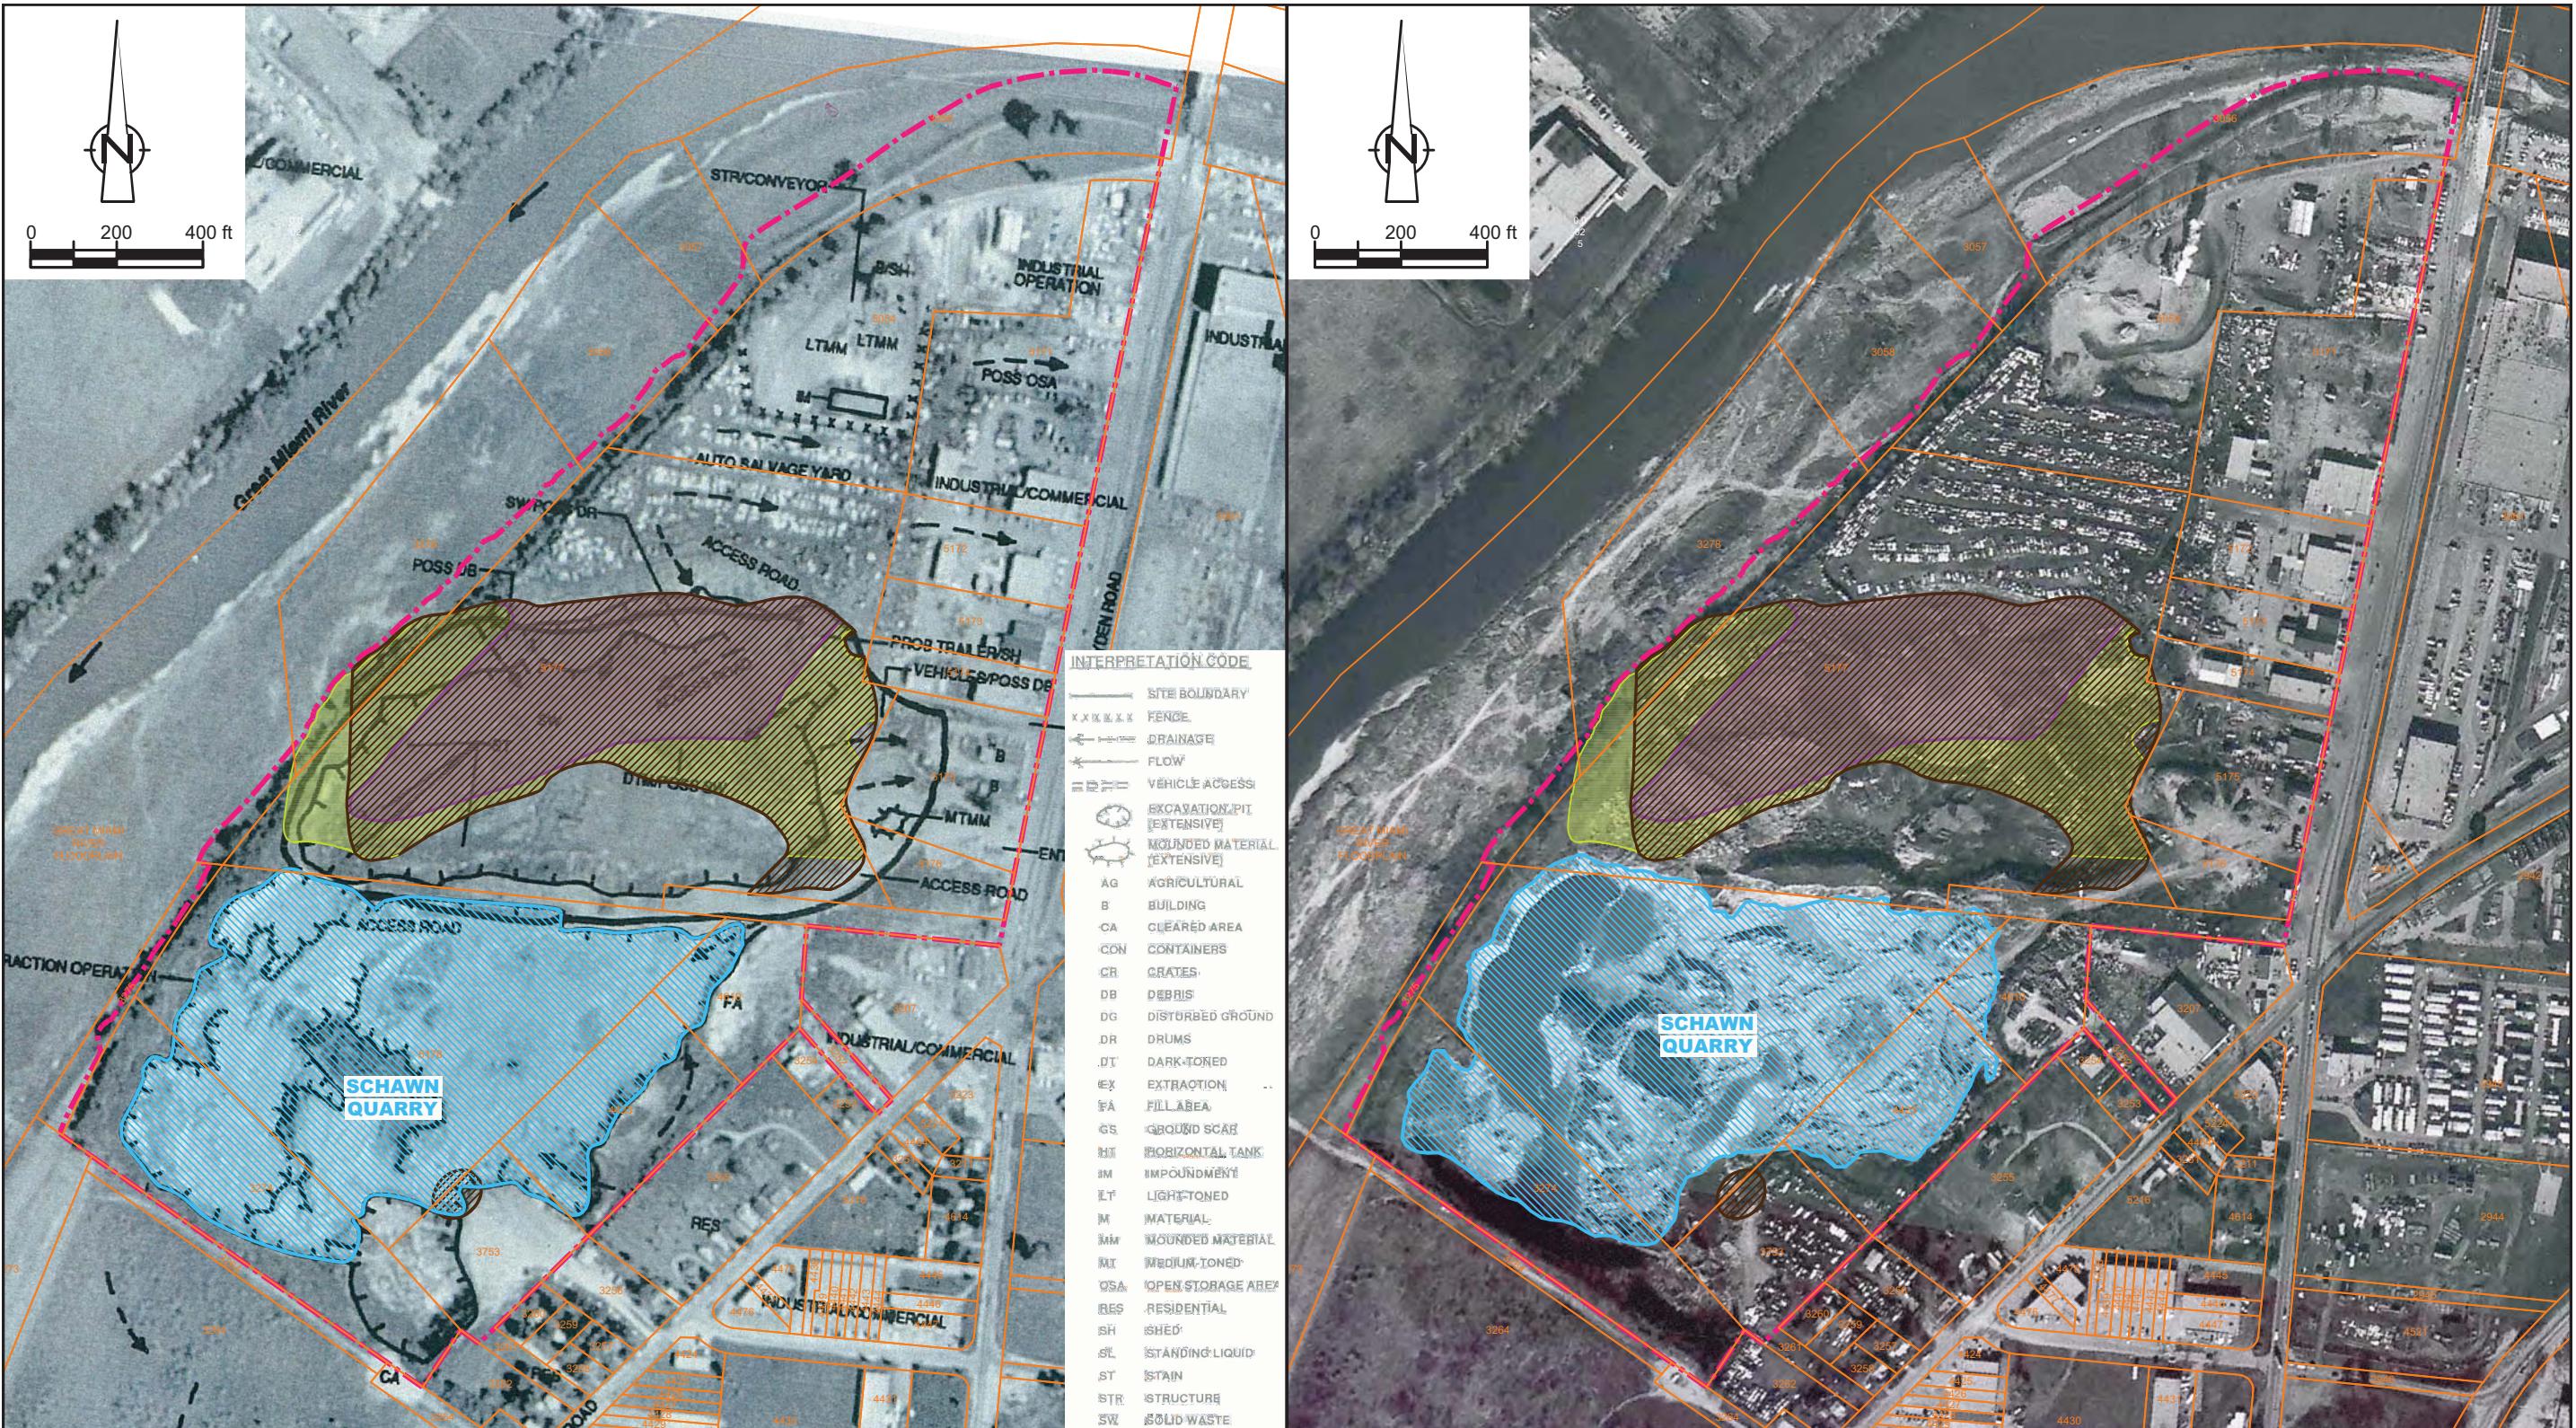
figure 8

AERIAL PHOTOS 1969-1975
SOUTH DAYTON DUMP AND LANDFILL SITE
Moraine, Ohio

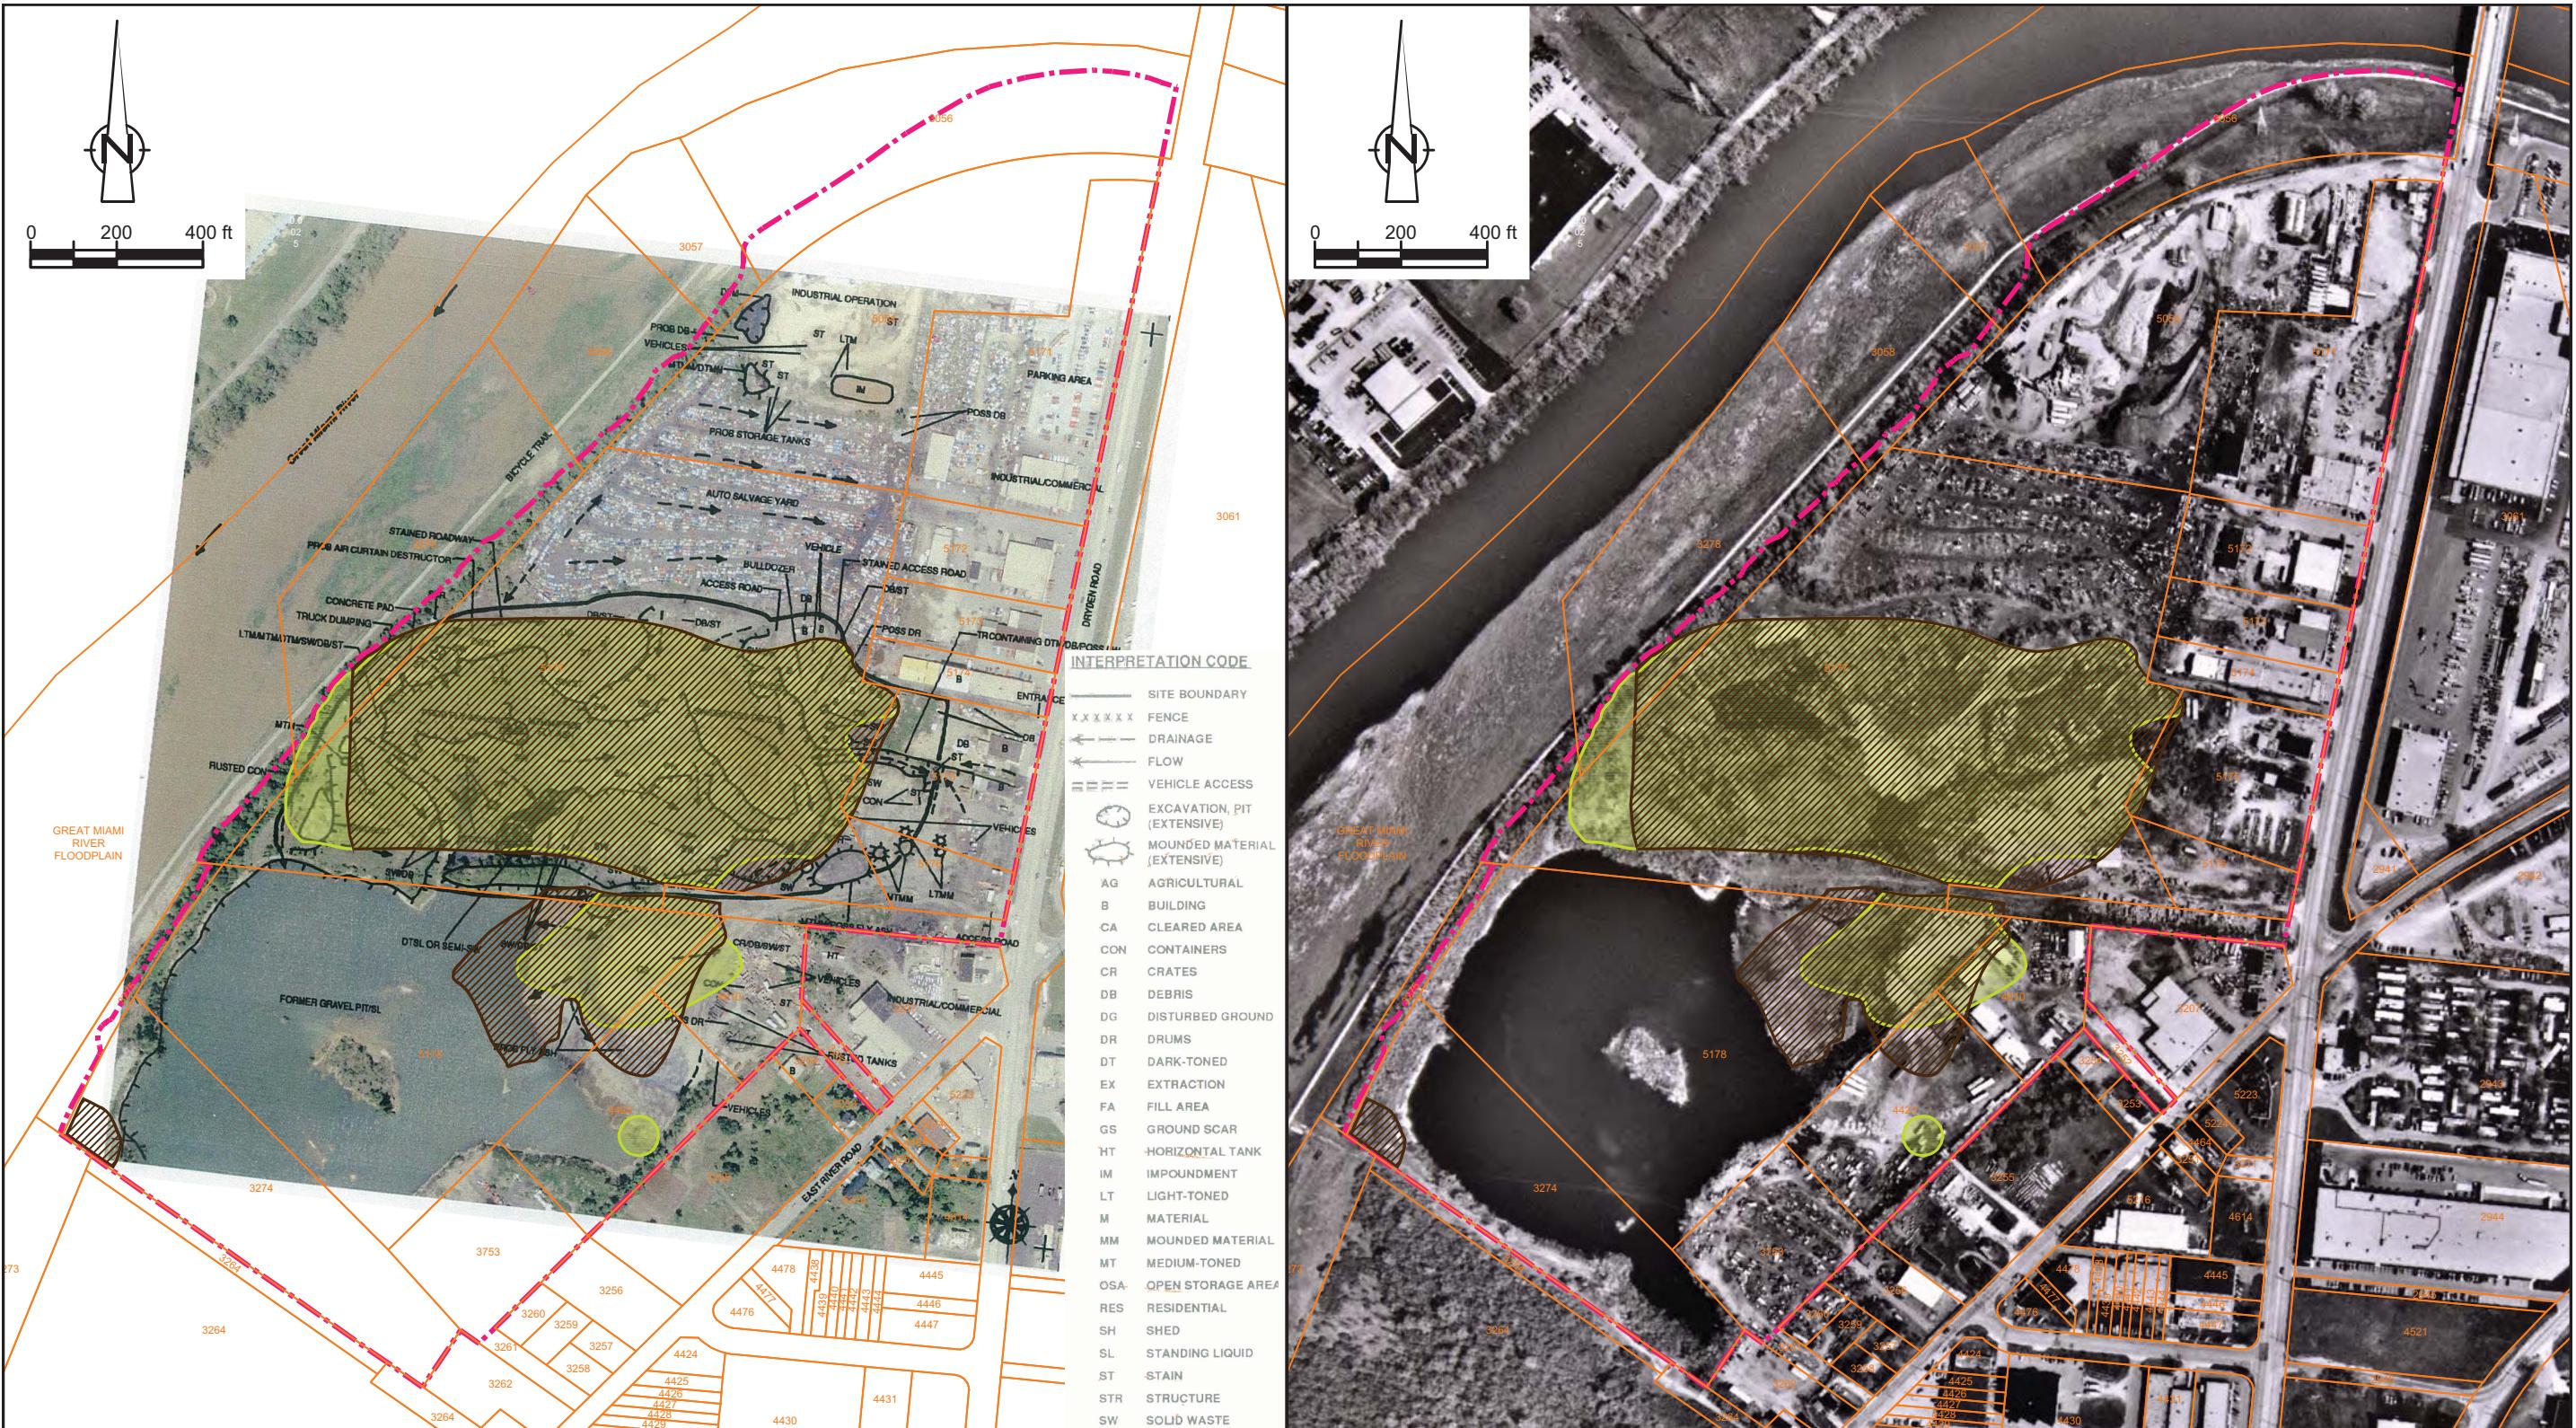
figure 12

AERIAL PHOTOS 1981-1990
SOUTH DAYTON DUMP AND LANDFILL SITE
Moraine, Ohio
